# FARM BROOK SITE 2A DAM CT 01546

## PHASE I INSPECTION REPORT NATIONAL DAM INSPECTION PROGRAM

SEPTEMBER 1981

IDENTIFICATION NO: CT-01546  
NAME OF DAM: Farm Brook Site 2A Dam  
TOWN: Hamden  
COUNTY AND STATE: New Haven County, Connecticut  
STREAM: Wilmot Brook  
DATE OF INSPECTION: June 2, 1981

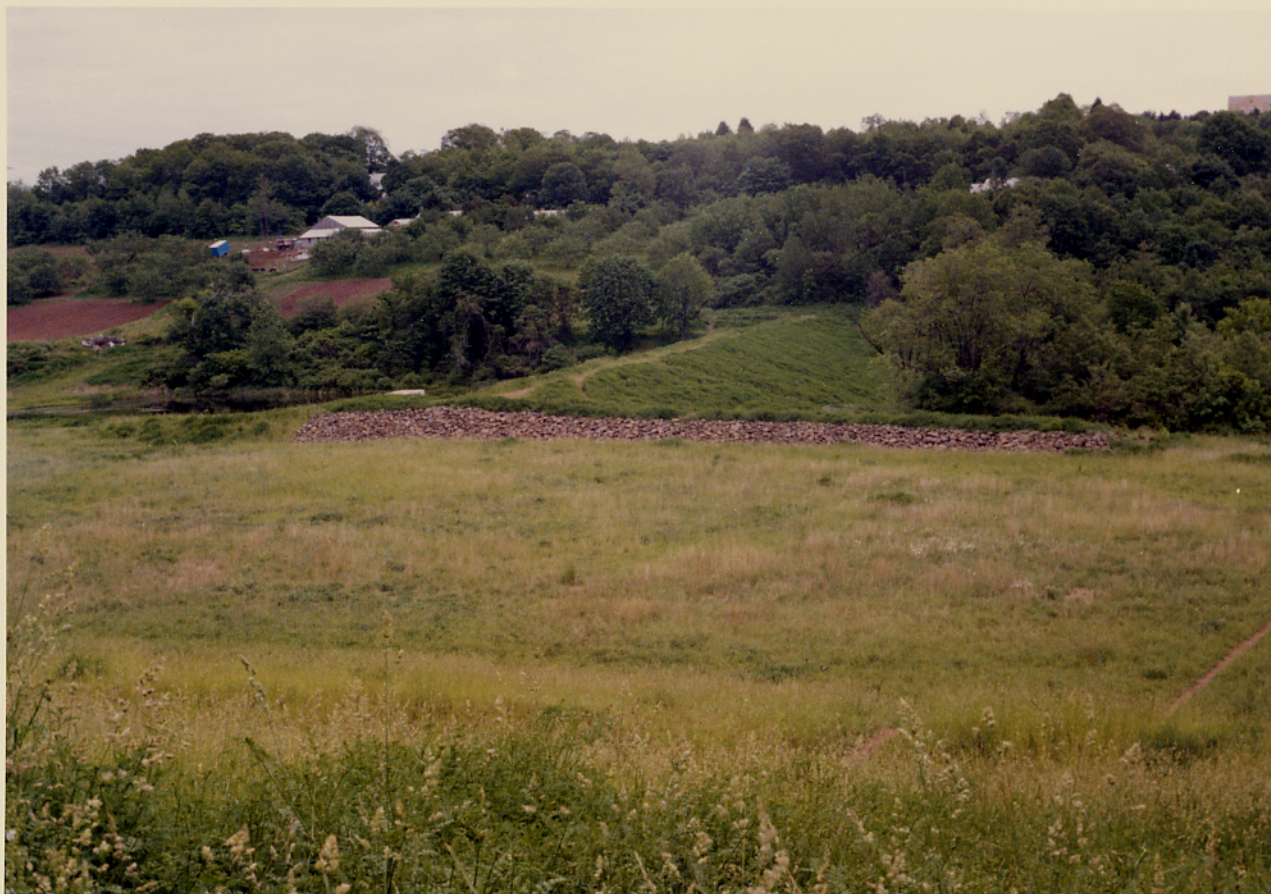
OVERVIEW PHOTO TAKEN JUNE 2, 1981

Abutting the west end of the dam, is the emergency spillway which is covered with a stable growth of vegetation. As shown in the Overview Photo and Photos 1, 2, 4 and 8, several motorcycle trails were noted along the grass covered spillway floor and the cut slopes which were protected with grass and vetch. The trails have been well ridden as indicated by the bare earthen areas. As noted on the general plan in Appendix B, one segment of the trail on the lower cut slope showed signs of minor erosion. The remaining vehicular paths appeared stable with no evidence of any detrimental erosion.

4. Restore vegetation on the bare earthen vehicular trails along the dam embankment and emergency spillway.
5. Repair concrete at fence post foundation on concrete impact basin.

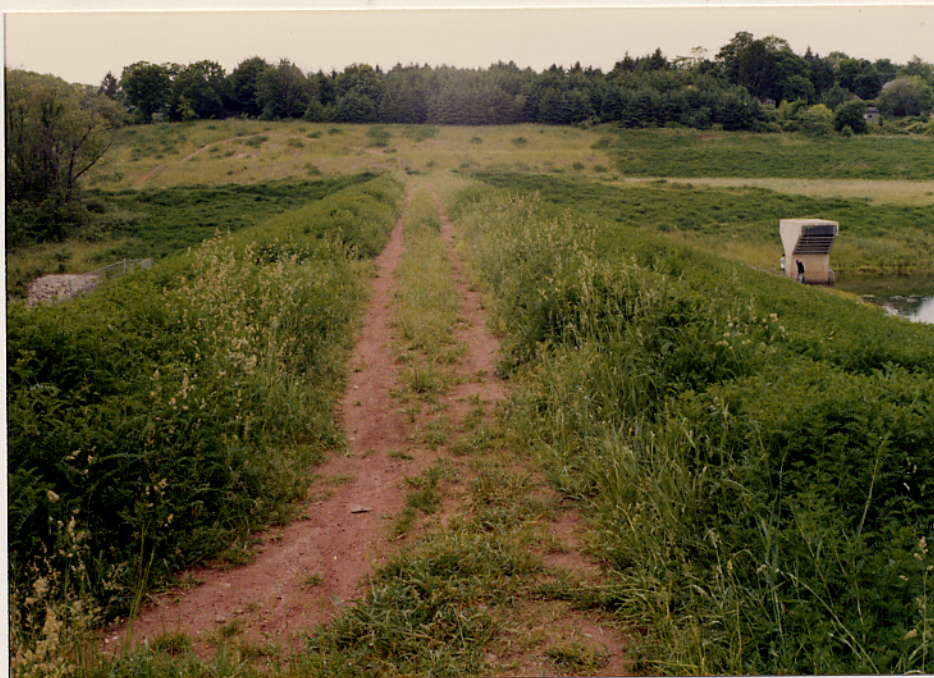
The dam consists of an earthfill embankment with a foundation drain trench underlying the downstream slope. As shown in Photos 1 & 2, the alignment appeared good with no sign of vertical or horizontal movement. Minor rutting was noted along the crest of the dam, resulting from vehicular traffic (see Photo 1). The exposed earth areas associated with the rutting were stable with no evidence of erosion. Trespassing was also observed along the upstream and downstream slopes (see Photo 3) of the dam embankment. Two wheeled vehicles, such as motorcycles have created bare earthen trails due to continuous usage. Although the vegetation has been removed, there was no sign of erosion at these areas. With the exception of

Photo 1 - View looking west along crest of dam. Note vehicular tracks with exposed earth areas.

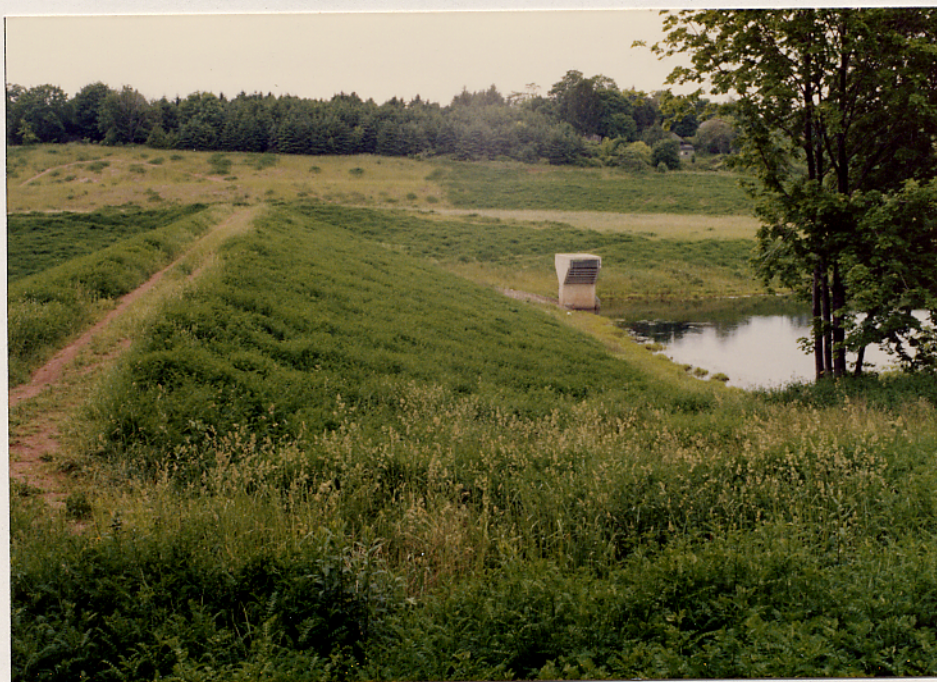
Photo 2 - Upstream slope of dam and west side slope of emergency spillway.

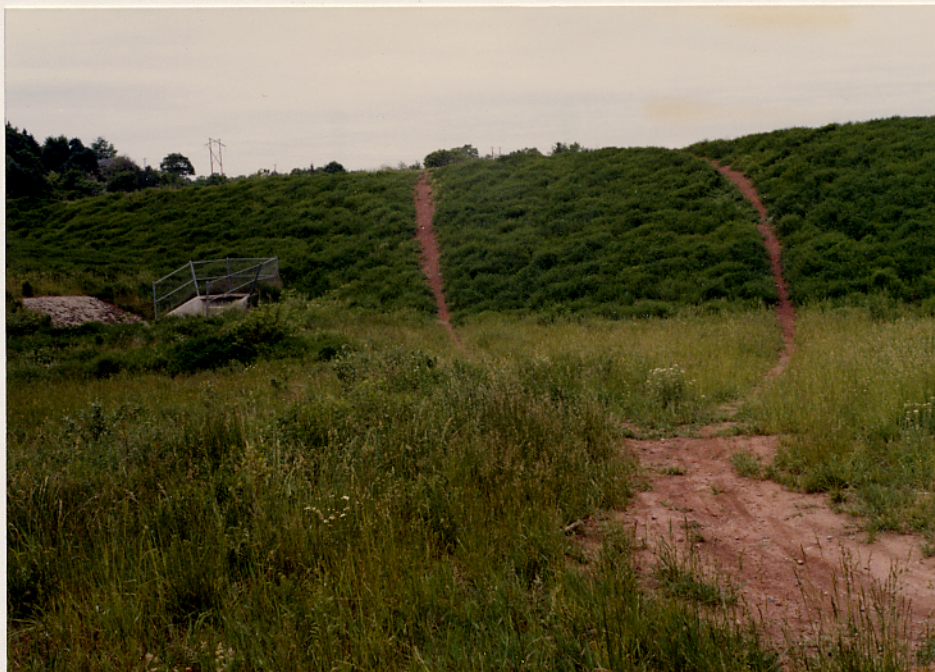
The visual inspection revealed no structural stability problems; however, an area of concern was noted. Several vehicular, bare earthen trails were observed on the crest and along the slopes of the dam embankment. Although there was no indication of erosion, the potential for such a problem exists if this vehicular trespassing continues.

Photo 3 - View of downstream slope of dam embankment. Note vehicular trails.

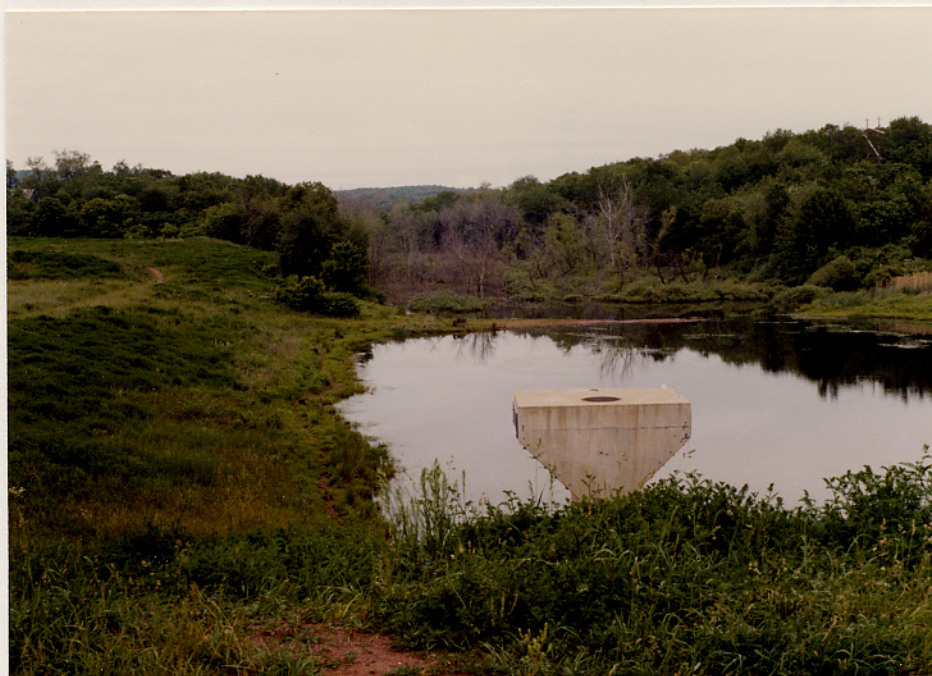
Photo 4 - Upstream reservoir area with principal spillway in foreground.

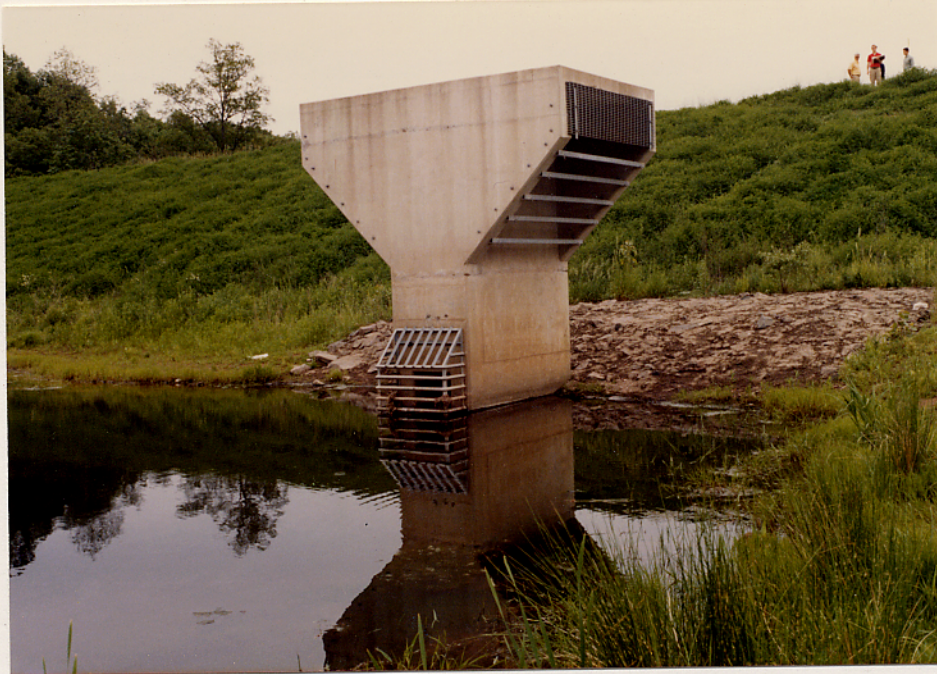
Impounded stormwater runoff and the normal flow to the reservoir passes under the dam embankment through the principal spillway. Consisting of a reinforced concrete intake riser, 30" pipe and impact basin, the principal spillway is generally in good condition. Numerous pock marks, possibly resulting from bullet impacts, were located on the north, south and east sides of the intake riser. Structurally sound and well painted, the steel trash racks at the high orifice and the crest riser were clean and free of debris as shown in Photo 5. Last operated in 1979, the slide gate at the low orifice was closed and fully submerged, preventing its inspection. Immediately south of the riser, the grouted riprapped area was in good condition with no indication of any cracking or failure.

Photo 5 - Two Stage reinforced concrete intake riser. Note grouted riprap area.

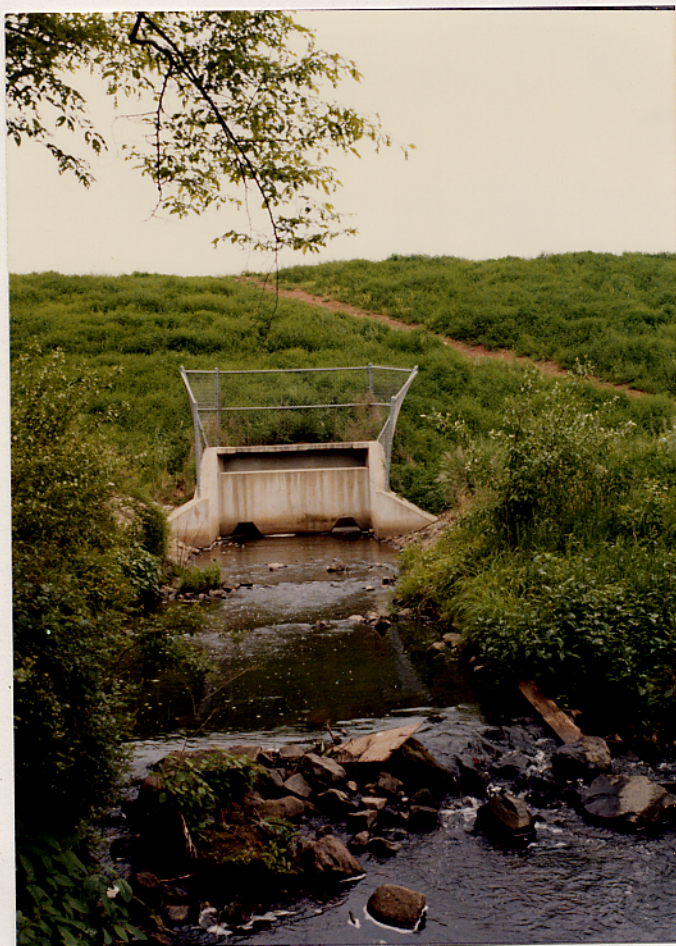
Situated on the downstream side of the dam is the reinforced concrete impact basin which is in good condition. As shown in Photos 6 and 7, the chain linked fence around the impact basin outlet, was tilted. The concrete at the base of the east and west center posts was cracked causing this problem. Directly downstream of the impact basin the riprapped areas, grouted and non-grouted, were stable and in good condition.

Photo 6 - Reinforced concrete impact basin. Note tilted fence.

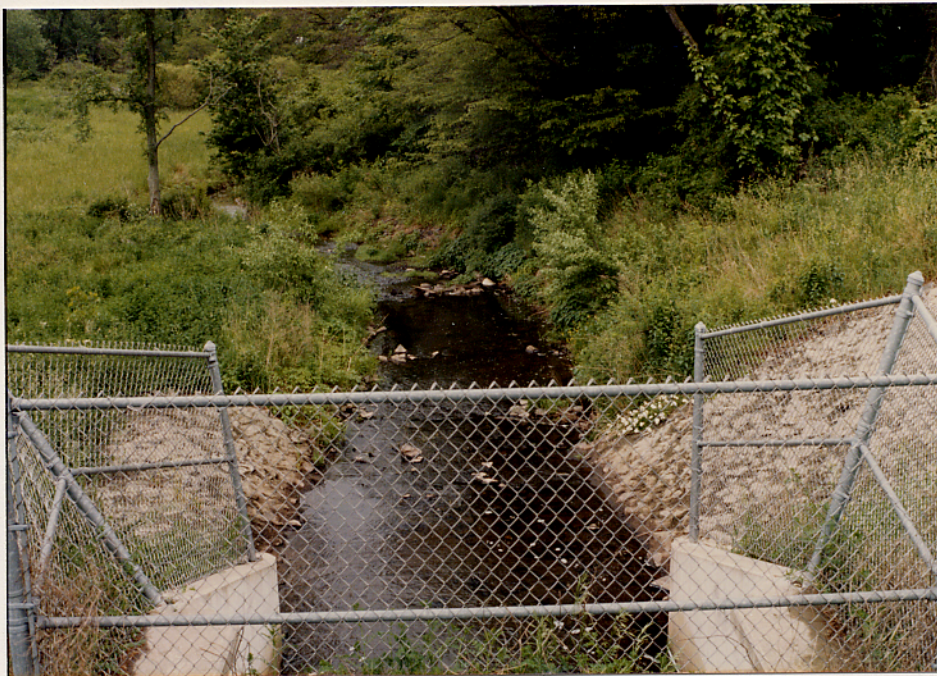
As shown in Photo 7, the channel downstream from the principal spillway is in good condition with no accumulation of debris. The riprapped areas immediately beyond the impact basin were stable with no evidence of failure. Minor brush growth and a few overhanging trees were noted along the channel farther downstream.

Photo 7 - Downstream Channel with impact basin in foreground. Note cracked concrete at base of fence posts.

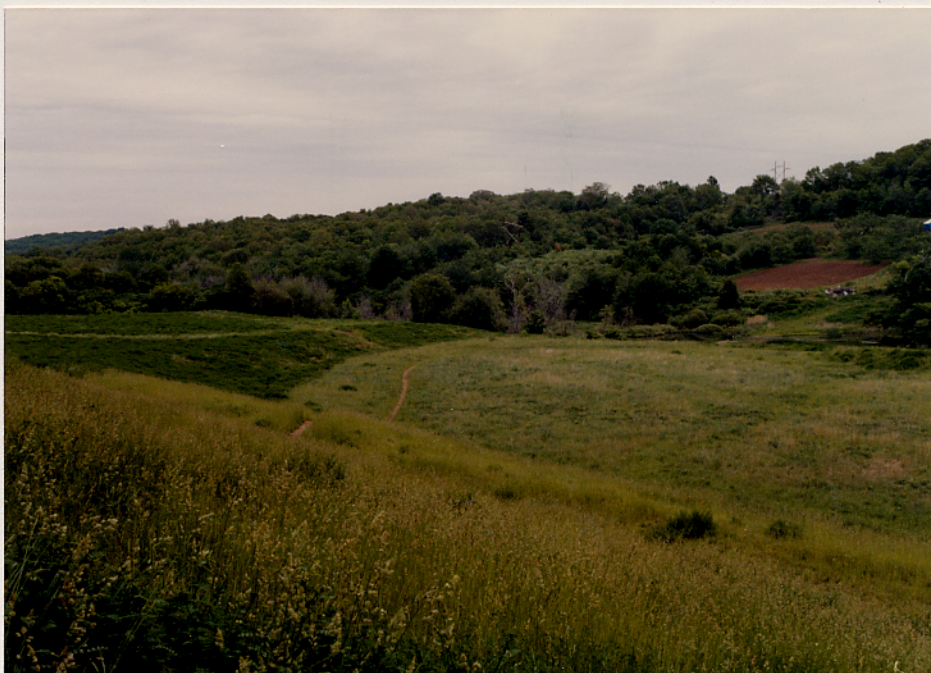
Photo 8 - View looking at approach channel of emergency spillway. Note vehicular trail.
